**CALIFORNIA REGIONAL WATER QUALITY CONTROL BOARD - SAN DIEGO REGION
WATERSHED MANAGEMENT PROGRAM**

FACILITY INSPECTION REPORT

Sprinter Rail Project

FACILITY: North County Transit District Sprinter Rail (WDID) 9 37C322900 INSPECTION DATE: 11/30/07

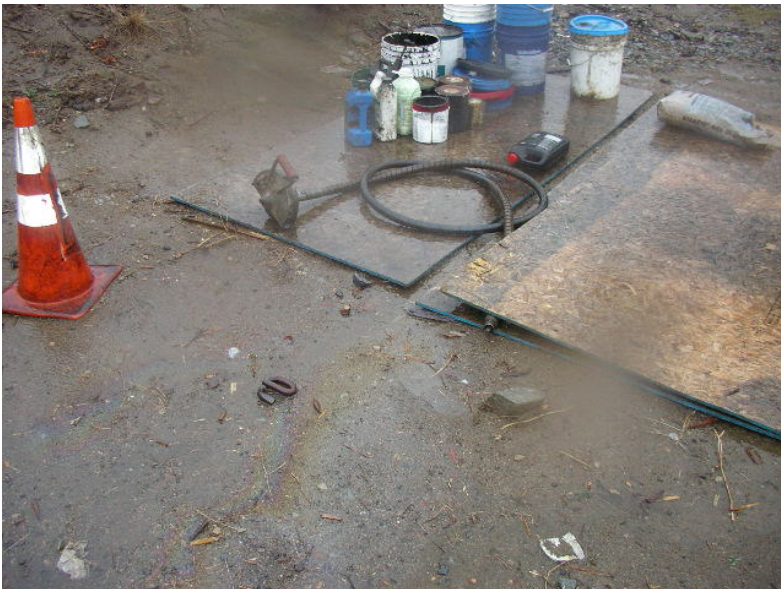
739. Construction materials left out in the rain give off a rainbow sheen of pollutants in the runoff.

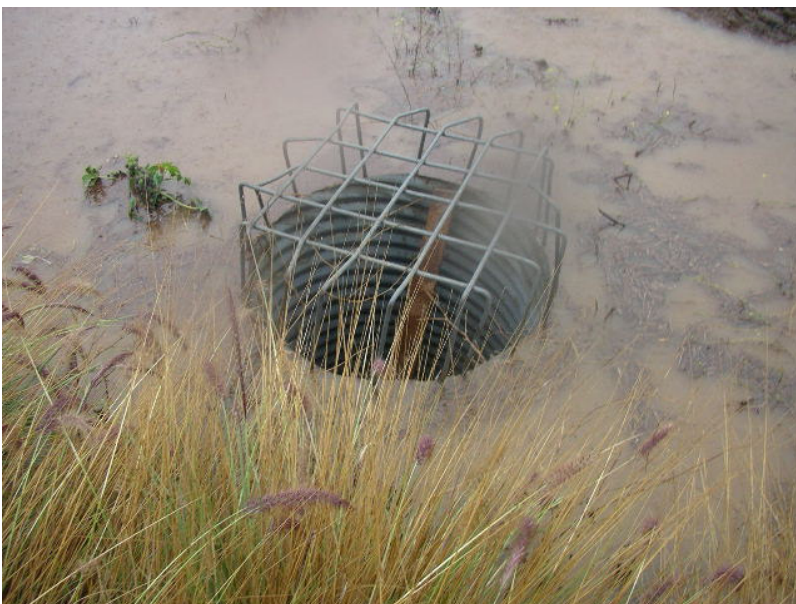
740. Storm drain inlet with no protections. Sediment laden water is discharging into the inlet.

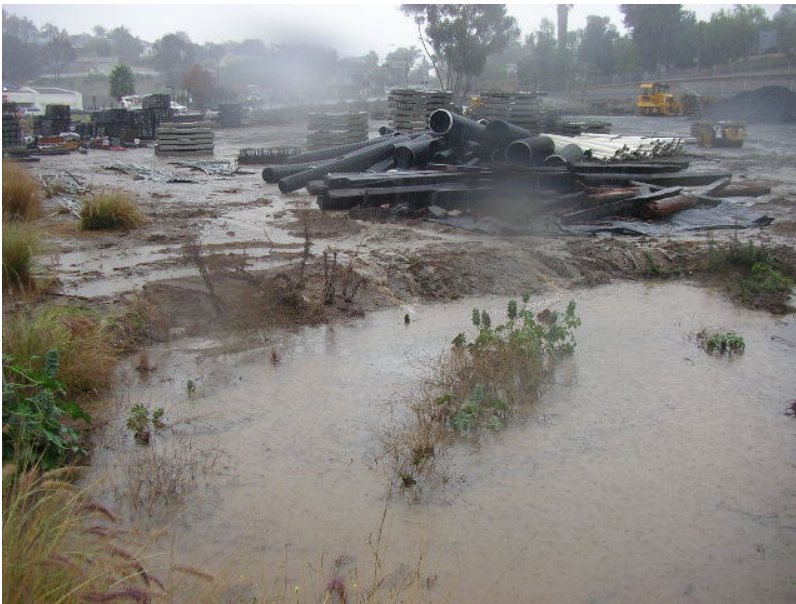
741. Runoff from the construction storage yard leading to the unprotected storm drain inlet in photo 740.

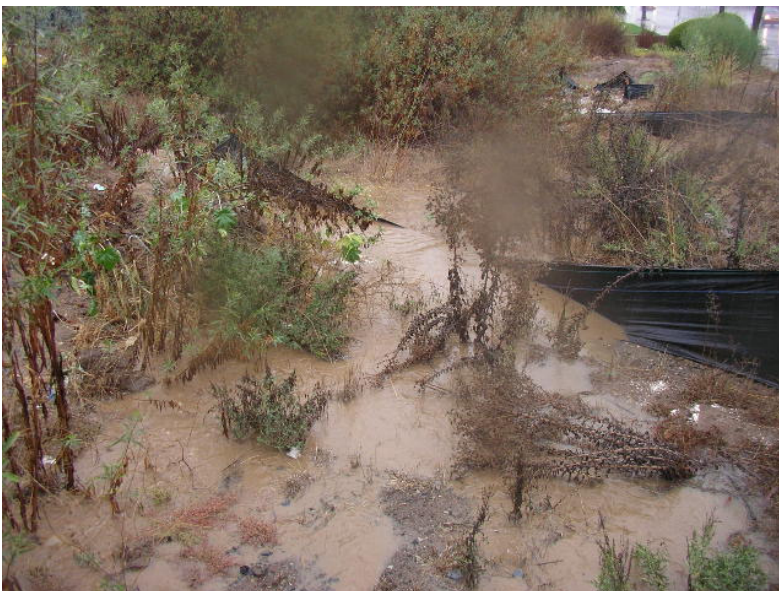
743. Silt fence failing from the sediment laden water in photo 742.

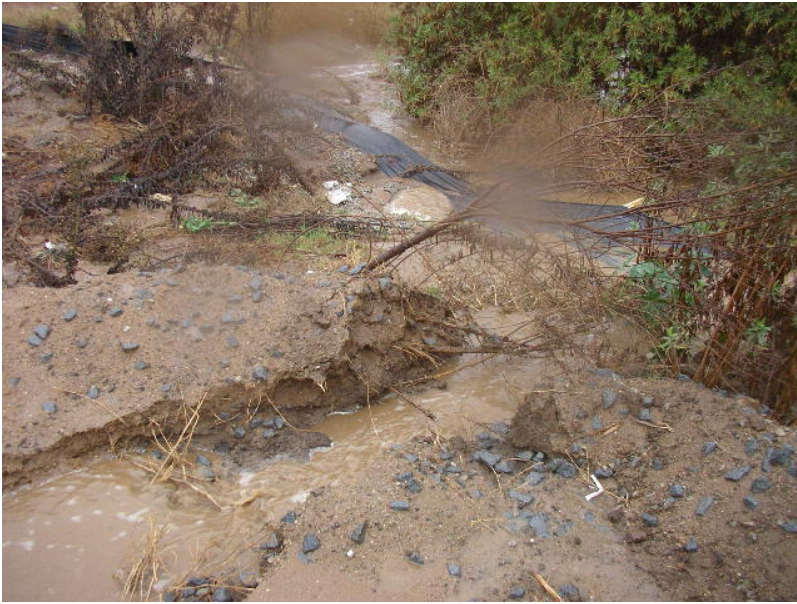
744. Gully erosion and silt fence failing from the sediment laden water.

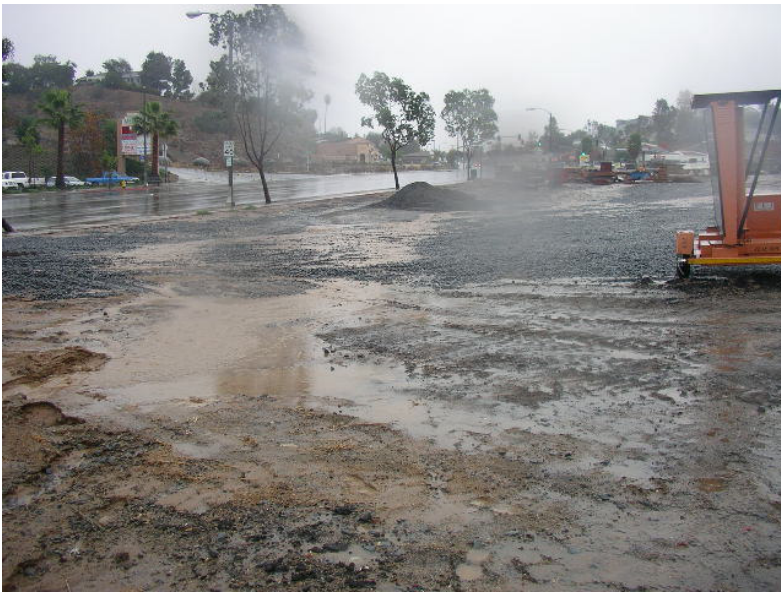
745. Sediment laden water flowing across the construction storage yard to the inlet in photo 746.

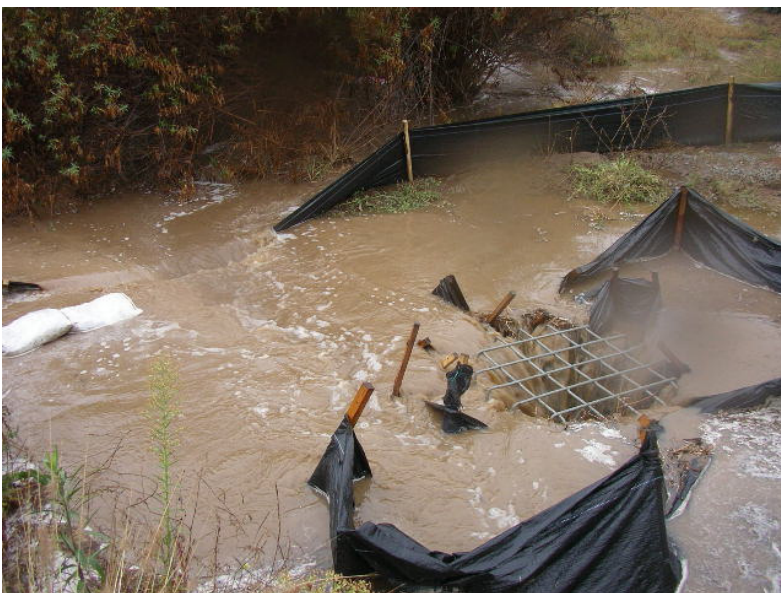
746. Discharge of sediment laden water to a storm drain inlet. Silt fence failed.

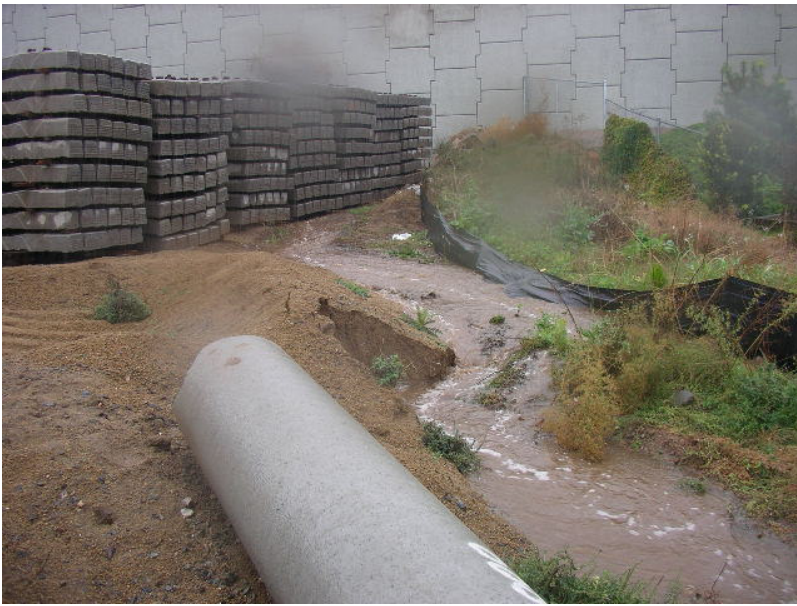
748. Runon from offsite flows through the construction storage yard picking up sediment. Sediment laden water flowing through the construction storage yard.

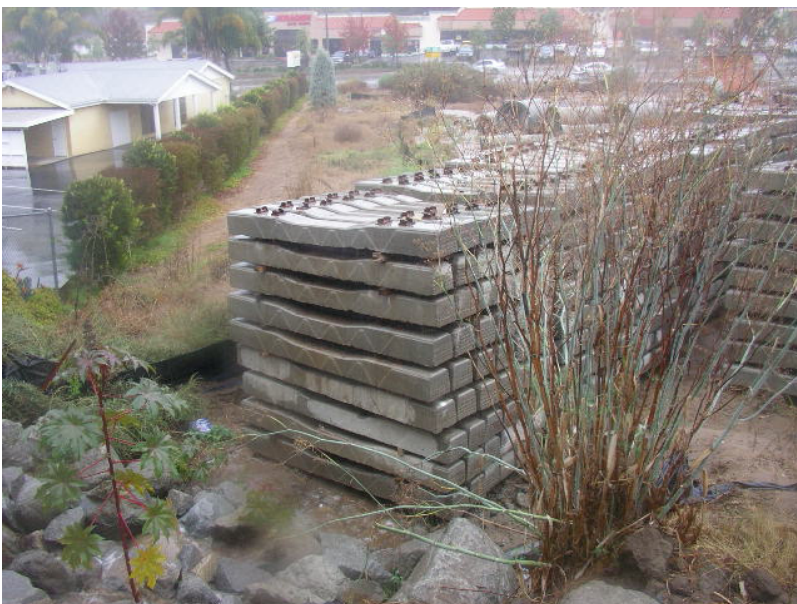
750. Run on from photo 749 flows through the construction storage yard.

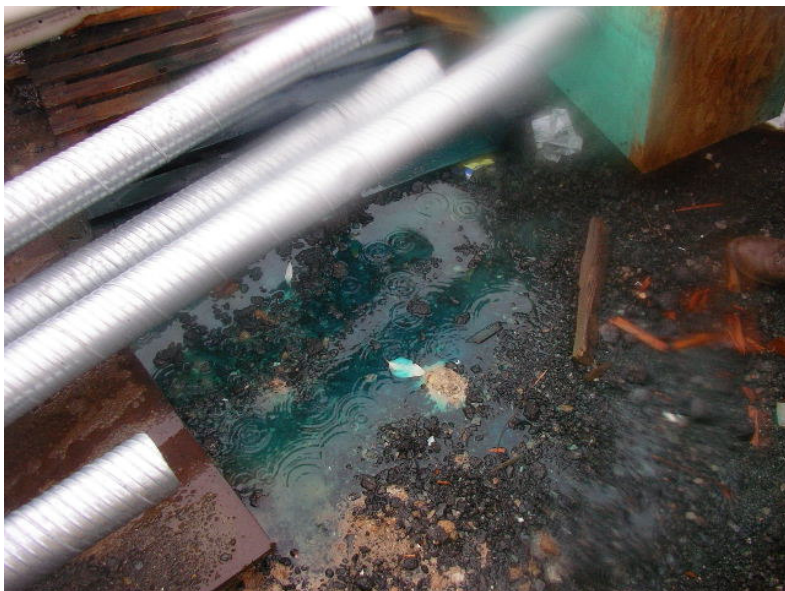
752. Construction materials are staining the storm water fluorescent blue.

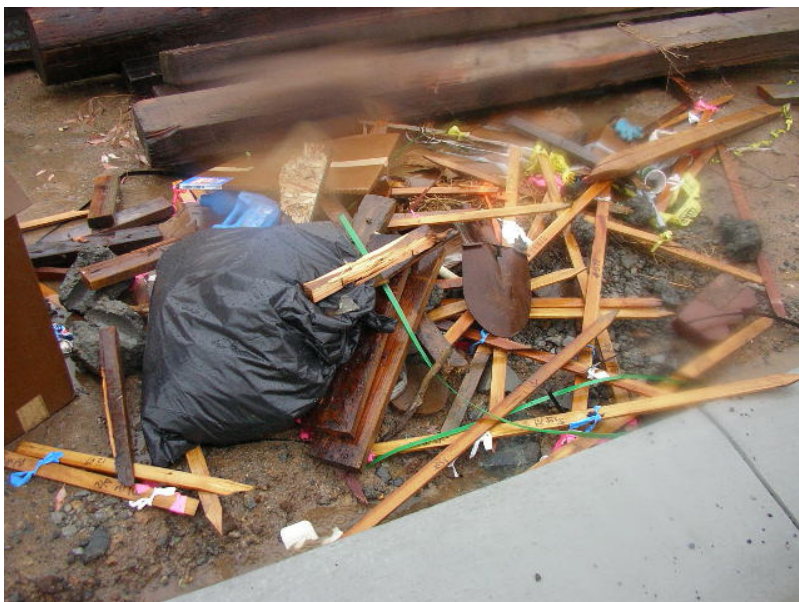
753. Construction waste stored outside without cover or containment to prevent contact with storm water.

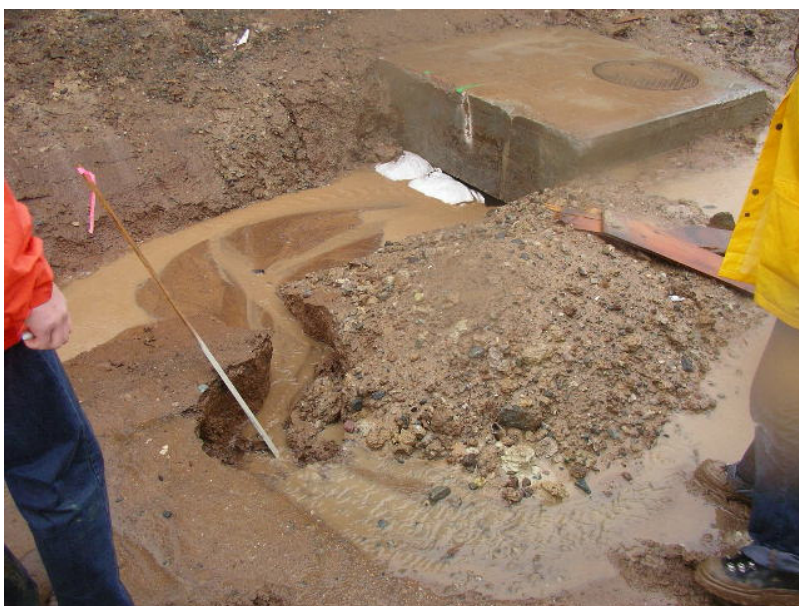
754. Storm drain inlet does not have adequate controls. Sediment laden water and sediment are discharging into the inlet.

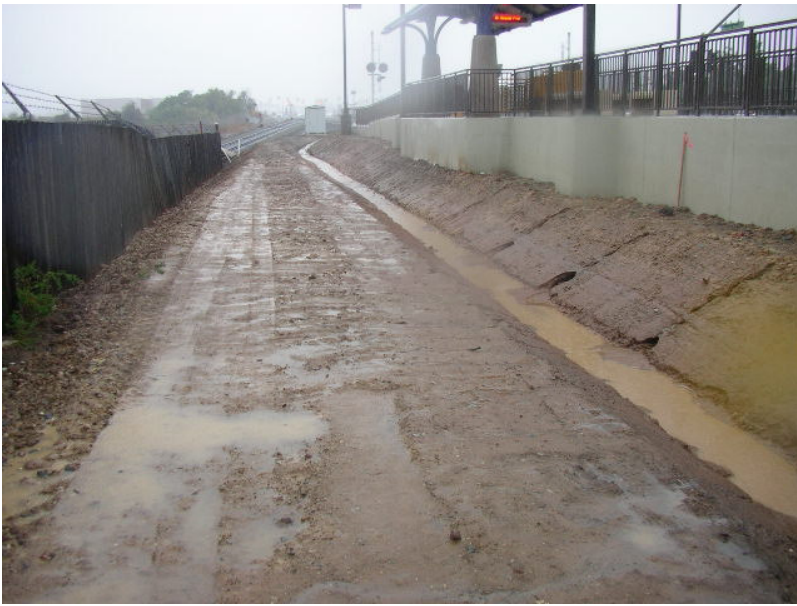
756. Unlined dirt channel leading to the inlet in photo 754 is running with sediment laden water.

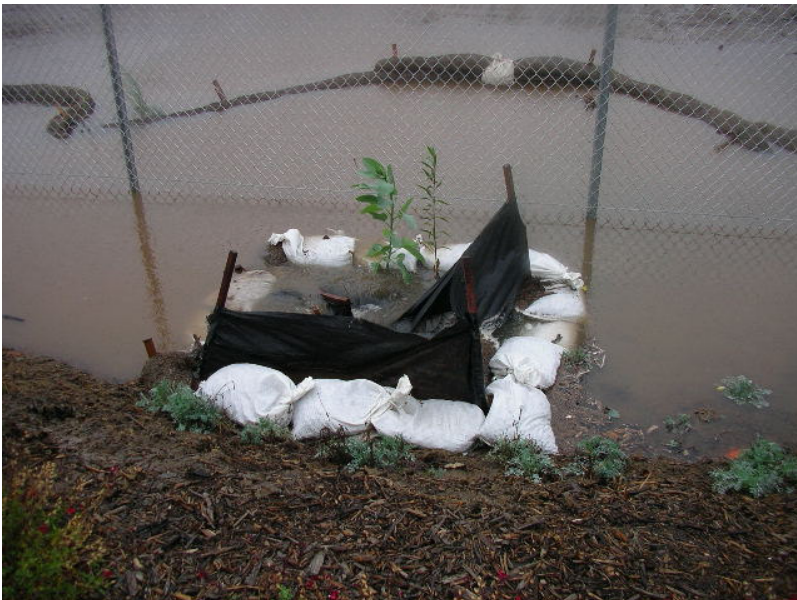
757. Storm drain inlet protection is over topped and sediment laden water is discharging into the inlet.

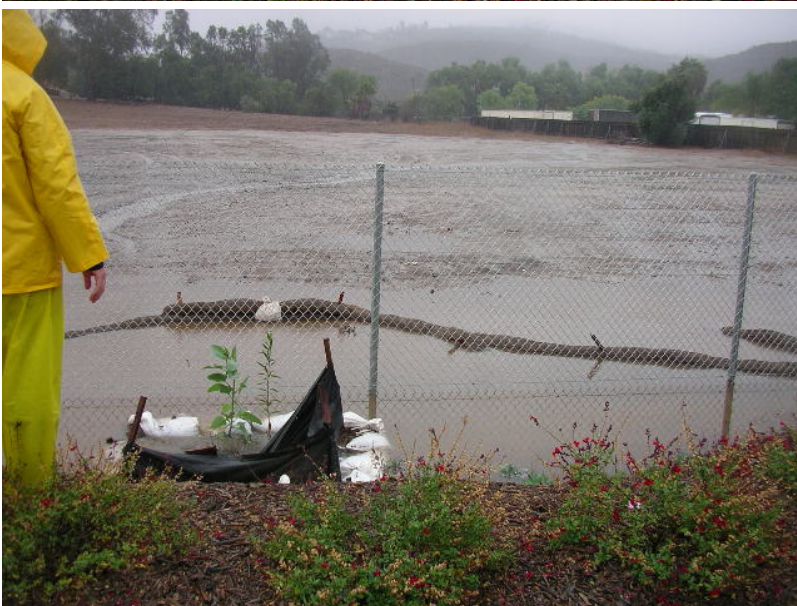
758. Another view of the inlet in photo 757 shows a large amount of disturbed soil around the inlet.

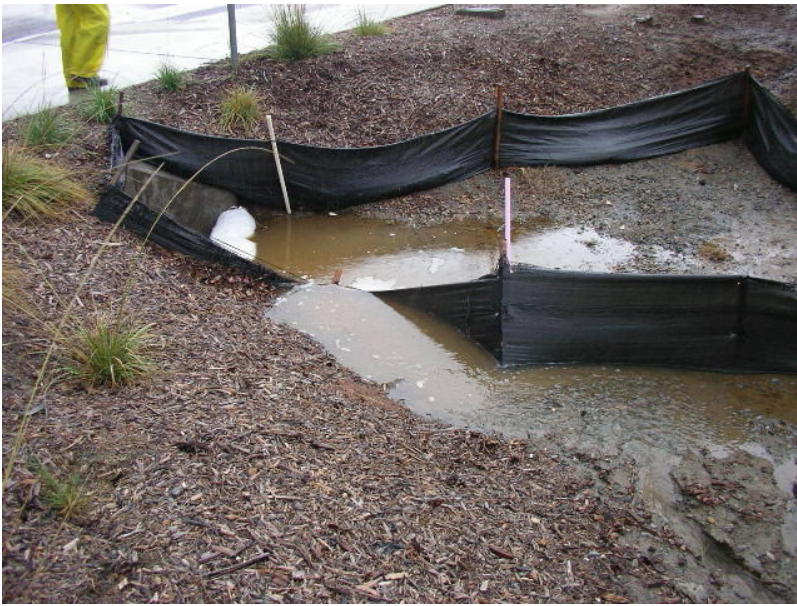
760. Sediment laden water discharging into storm drain inlet.

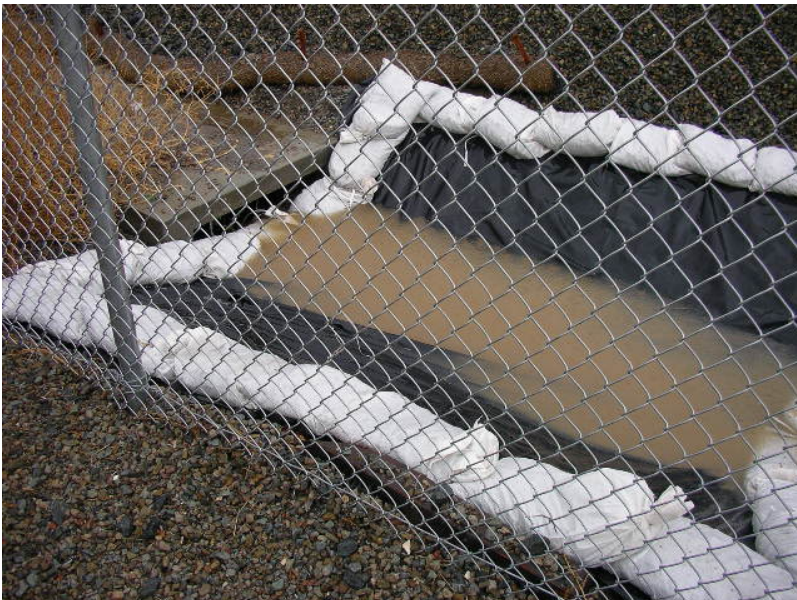
761. Sediment laden water discharging into storm drain inlet.

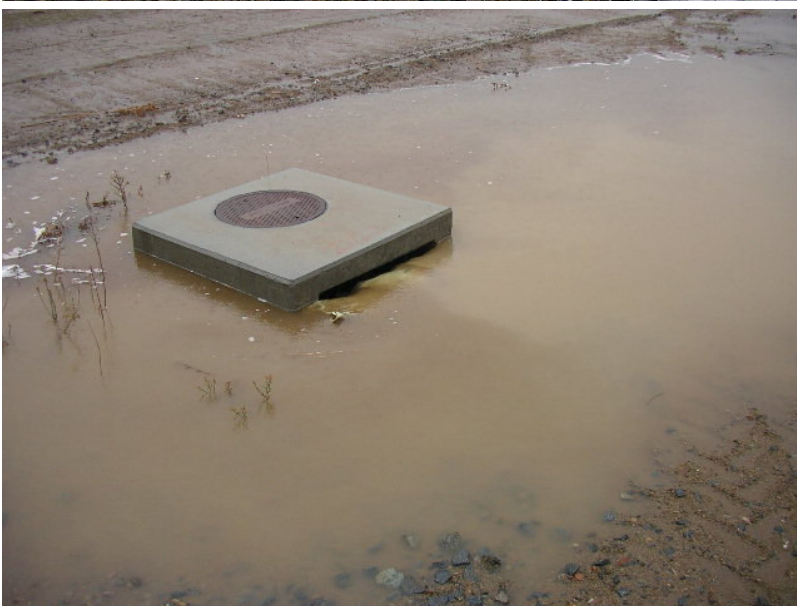
762. Sediment laden water discharging into storm drain inlet.

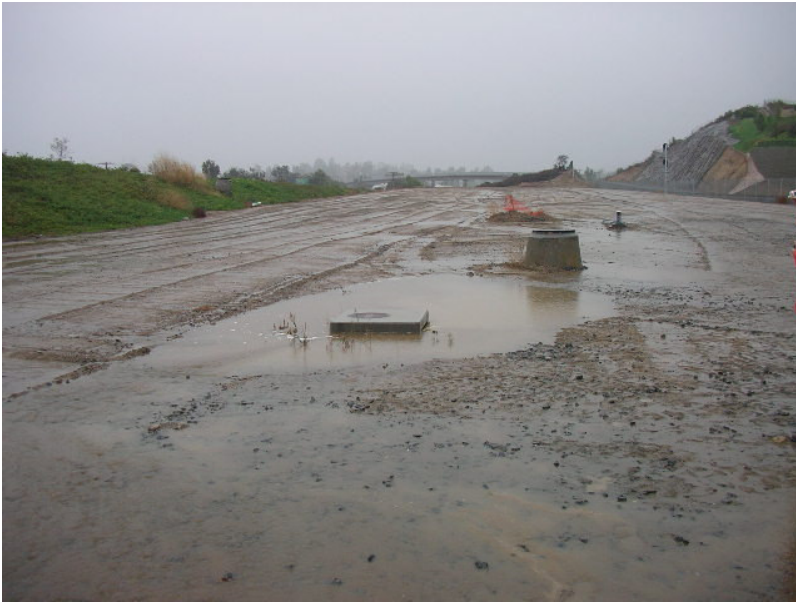
763. Another view of the inlet in photo 762 shows the large expanse of disturbed soil surrounding the inlet without soil stabilization.

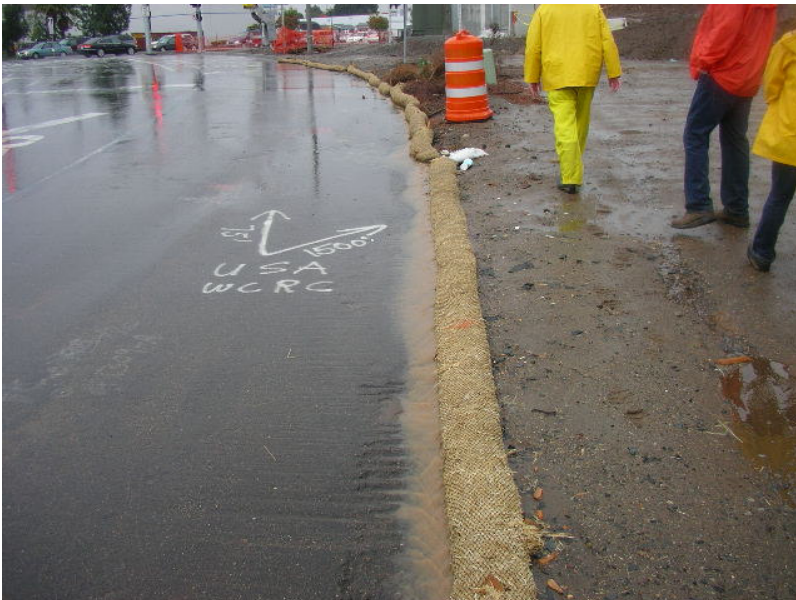
764. Sediment laden water is discharging from the site to the gutter. Fiber roll is not trenched and is ineffective.

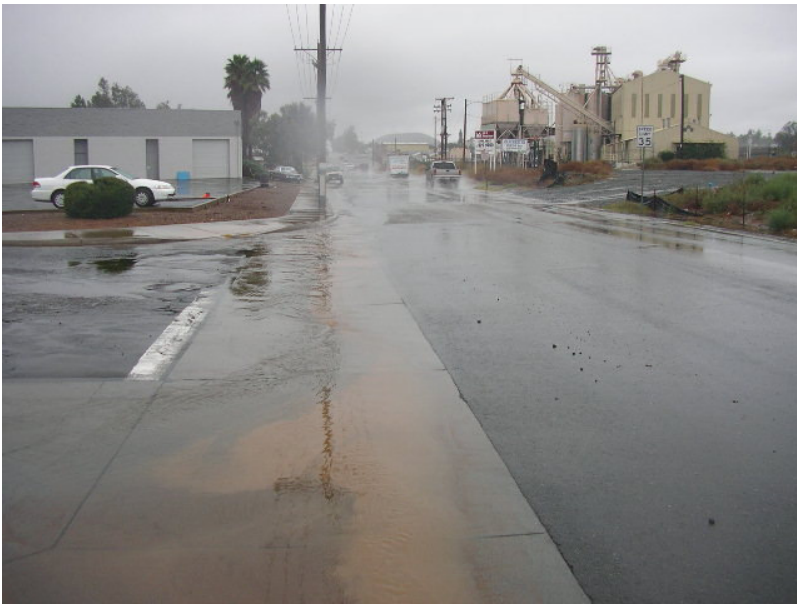
766. The sediment laden water in photos 765 and 764 flows down the street's gutter.

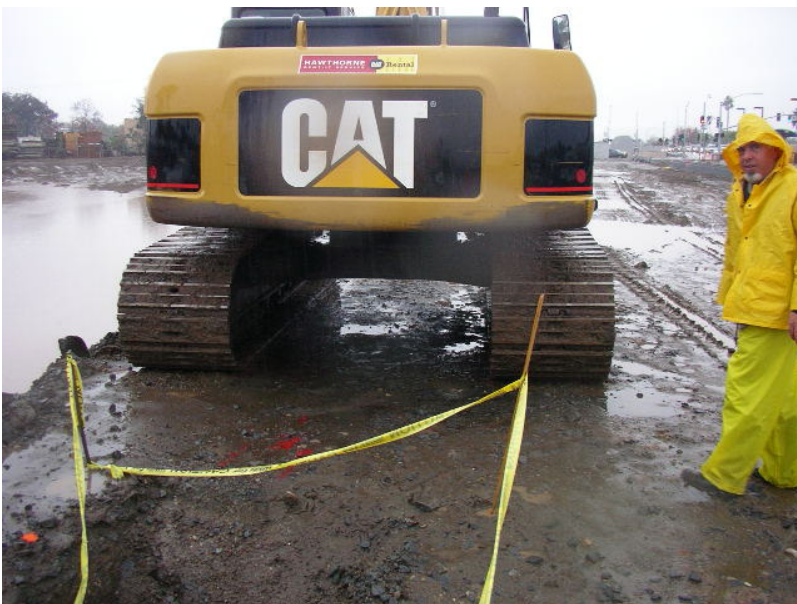
770. Construction equipment is stored without drip pans. No drip pans were present under any construction equipment. This is just one example.

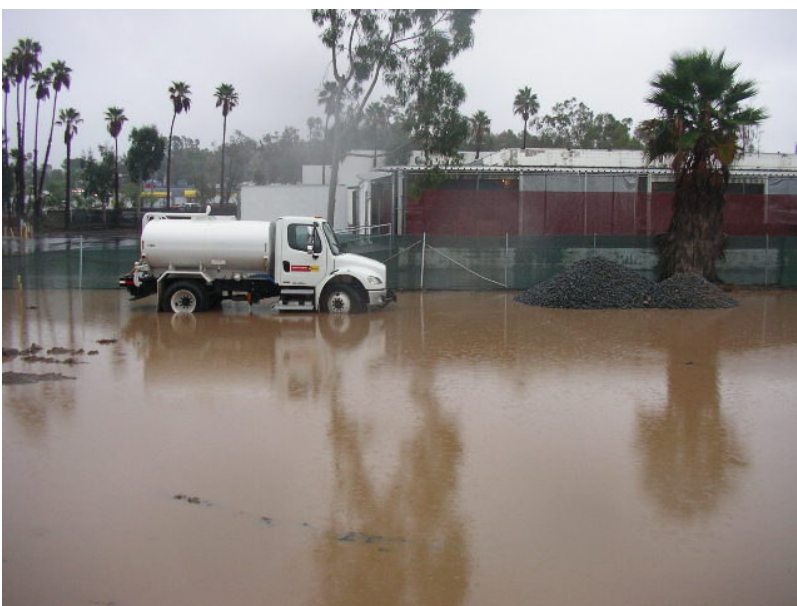
772. A water truck was improperly stored in a low area that ponds storm water.
